Traffic Quality on the Atlanta Regional Highway Network

VOLUME ONE: FREEWAYS (2010)

Prepared for The Georgia Department of Transportation by Skycomp, Inc. (Columbia, Maryland)

Publication Date: June 2011

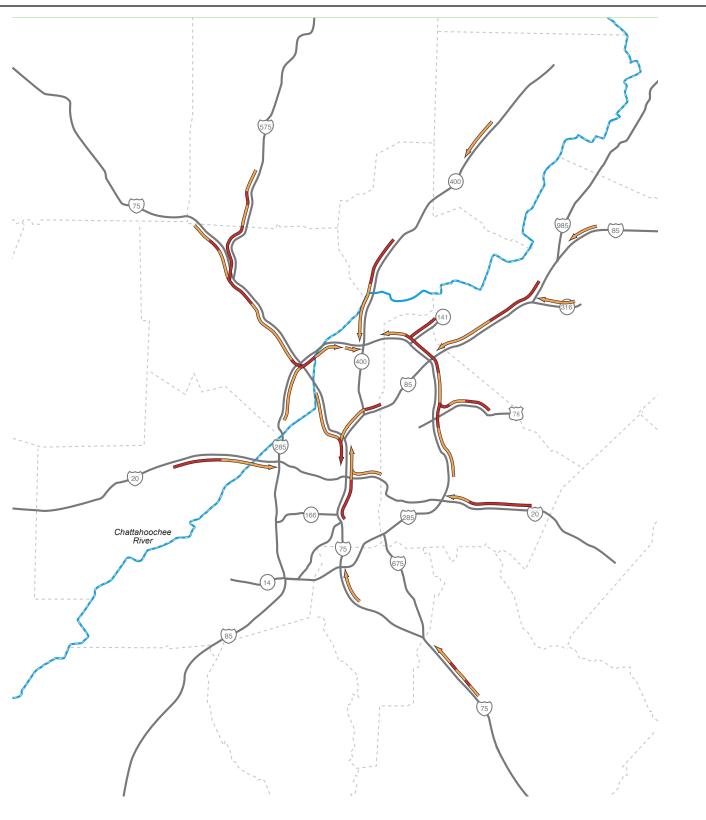
Morning Recurring Freeway Congestion (6:30 - 9:30 a.m.) 2010

This section of the report contains morning and evening regional graphics that depict all locations where congestion was found.

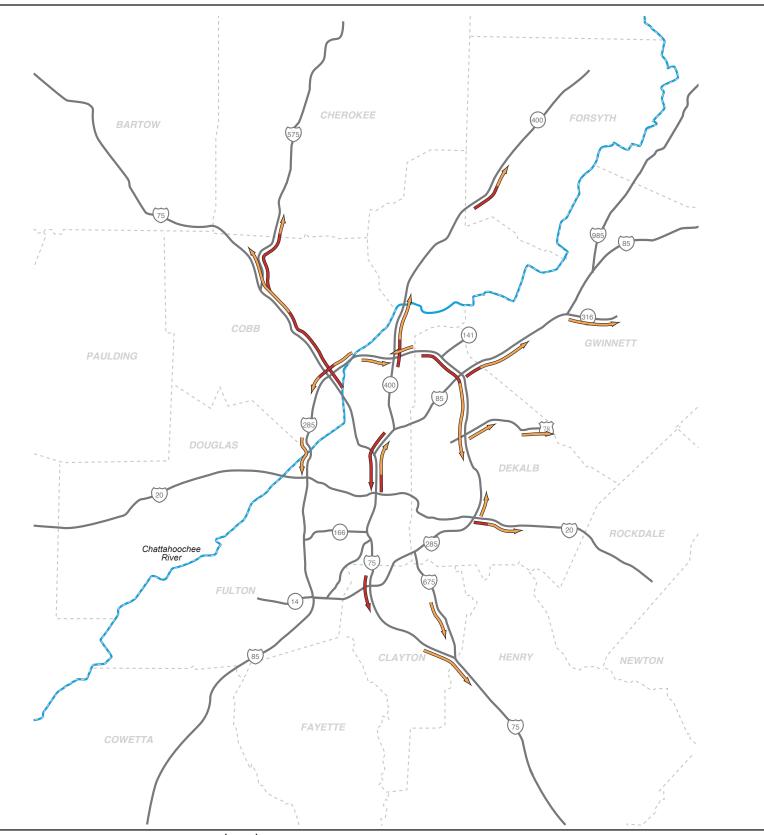
Evening Recurring Freeway Congestion (4:00 - 7:00 p.m.) 2010

Severe mainline congestion (<30 mph)

Moderate or intermittent mainline congestion (30-50 mph)

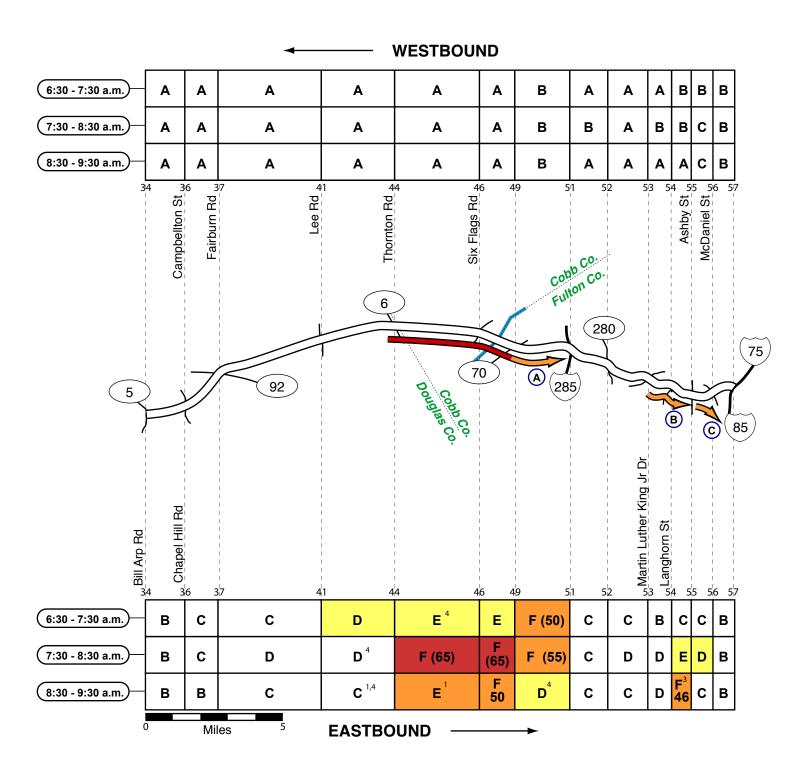
I-20 (Douglas/Cobb & Fulton Counties) - Morning

Potential Cause(s): Factors that may have exacerbated the congestion included: 1) traffic entering the mainline at the interchanges along this section of I-20; 2) two separate lane drops (4 lanes to 3) - one at Fulton Industrial Blvd (SR 70) - one between SR 6 and

Potential Cause(s): Eastbound congestion appeared to be caused or exacerbated by sun glare and the roadway geometrics (curves).

Note: In some cases, congestion in the left-turn lanes on the exit ramp extended back into the right lane on I-20.

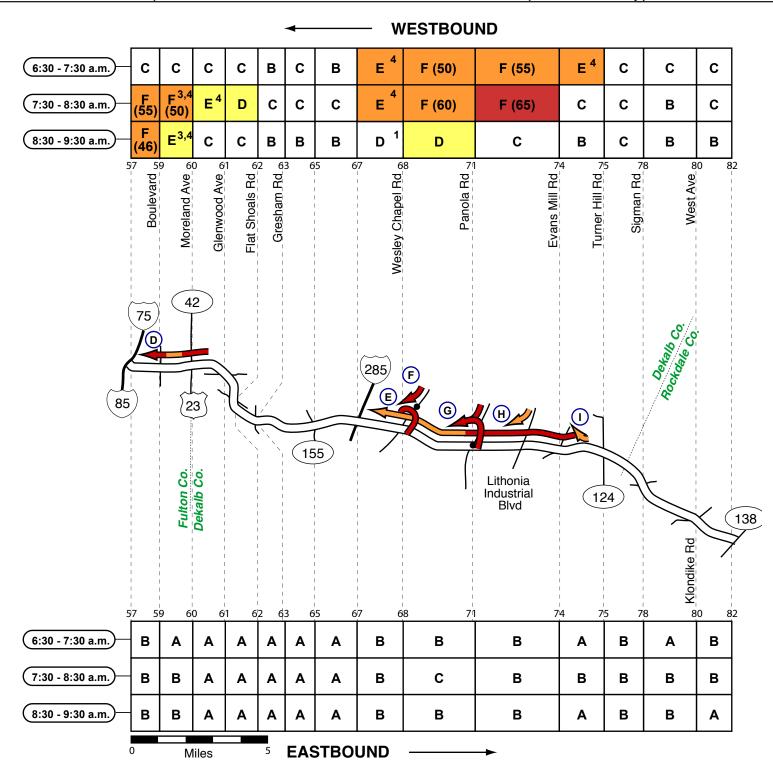
I-20 (Fulton/Dekalb & Rockdale Counties) - Morning

Potential Cause(s): Factors contributing to the congestion included: 1) the lane drop at the terminus of the HOV facility (5 lanes to 4); 2) congestion on the two-lane ramp to I-75 northbound (this congestion backed into the two right lanes, and ultimately across all lanes on I-20).

Potential Cause(s): Traffic entering the mainline at the interchanges along this section of I-20 appeared to exacerbate the congestion. Congestion between Evans Mill Rd and Panola Rd was particularly severe during the peak period with average speeds estimated at 20 to 40 mph; while congestion typically persisted west of Panola Rd.

Note: Congestion on Wesley Chapel Rd was typically found in both directions approaching the I-20 Interchange (left two lanes northbound; right two lanes southbound); the head of the queues was found either at the signals or at the head of the entrance ramp where vehicles merged into congested westbound flow on I-20. The lane drop (2 lanes to 1) on the entrance ramp may have exacerbated the congestion.

Note: Congestion on Panola Rd was typically found in both directions approaching the I-20 Interchange (left lane northbound; right lane southbound); the head of the queues was found either at the signals or at the head of the entrance ramp where vehicles merged into congested westbound flow on I-20.

Note: When congested, the head of the gueue was found where vehicles merged into westbound flow on I-20; the lane drop (2 lanes to 1) on the entrance ramp appeared to exacerbate congestion.

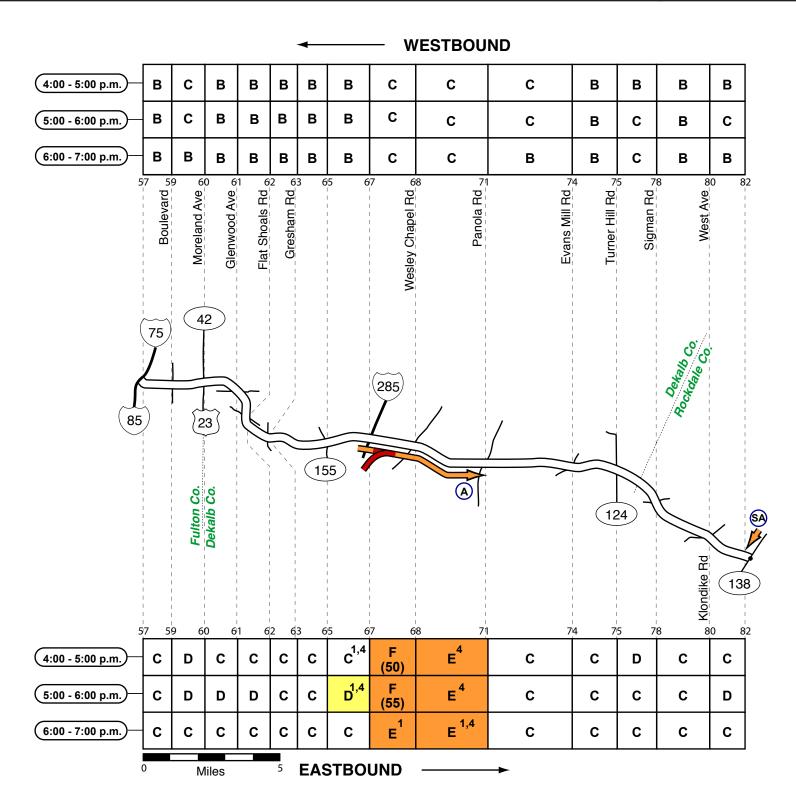
I-20 (Fulton/Dekalb & Rockdale Counties) - Evening

Potential Cause(s): The primary bottleneck was the series of lane drops (6 lanes to 3) between the I-285 merge and Wesley Chapel Rd.

Note: When congested, the queue at I-20 typically extended back through the upstream signal at Dogwood Dr.

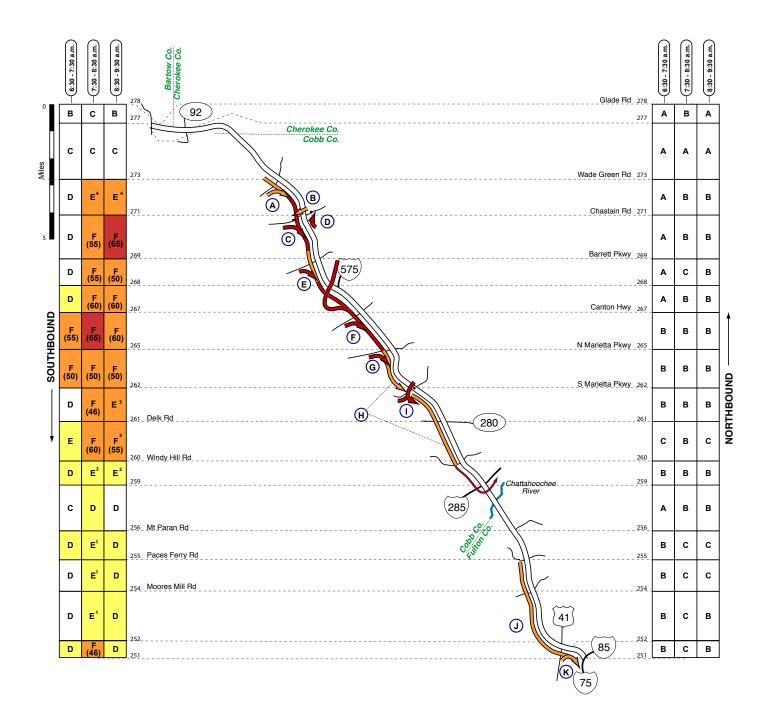
I-75 (Bartow/Cherokee/Cobb & Fulton Counties) - Morning

Note: The head of the queue was found at the ramp meter

Note: The head of the gueue was found at the ramp meter signal; congestion extended back into the "exit-only" lane on

Potential Cause(s): Factors contributing to the congestion were: 1) traffic entering at the interchanges along this corridor and; 2) congestion on the ramp to the Perimeter (Eastbound) extending

Note: The head of the queue was found at the ramp meter; congestion typically extended back into the mainline of S.

Potential Cause(s): The merging associated with the

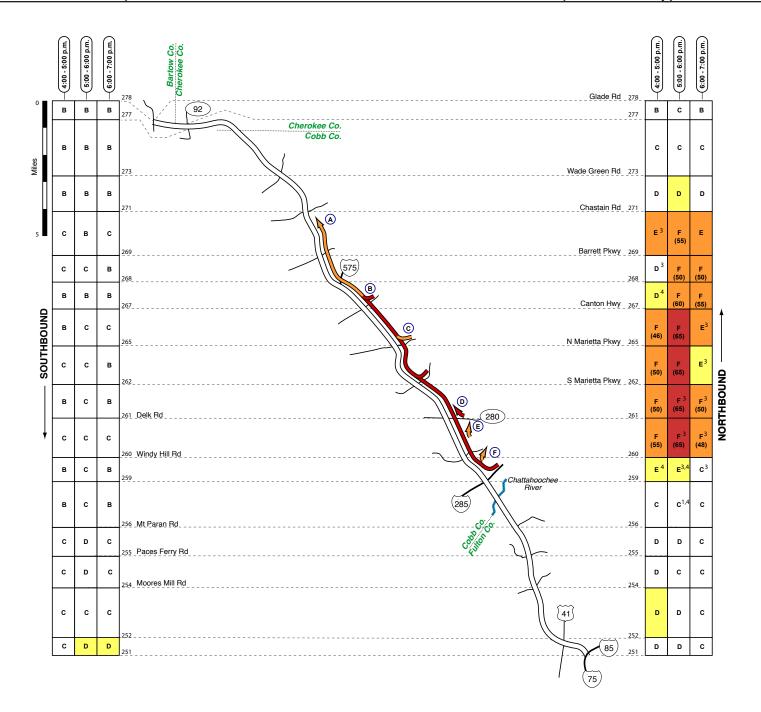
I-75 (Bartow/Cherokee/Cobb & Fulton Counties) - Evening

Potential Cause(s): Factors contributing to the congestion were: 1) the two separate lane drops at I-575 (6 lanes to 4) and Barrett Pkwy (4 lanes to 3) and; 2) merging associated with the Perimeter, Marietta Parkway (North and South), Canton Rd Connector and I-575

Note: The head of the queue was found at the ramp meter signal. During one observation, congestion extended back onto the flyover

Note: The head of the queue was found at the ramp meter.

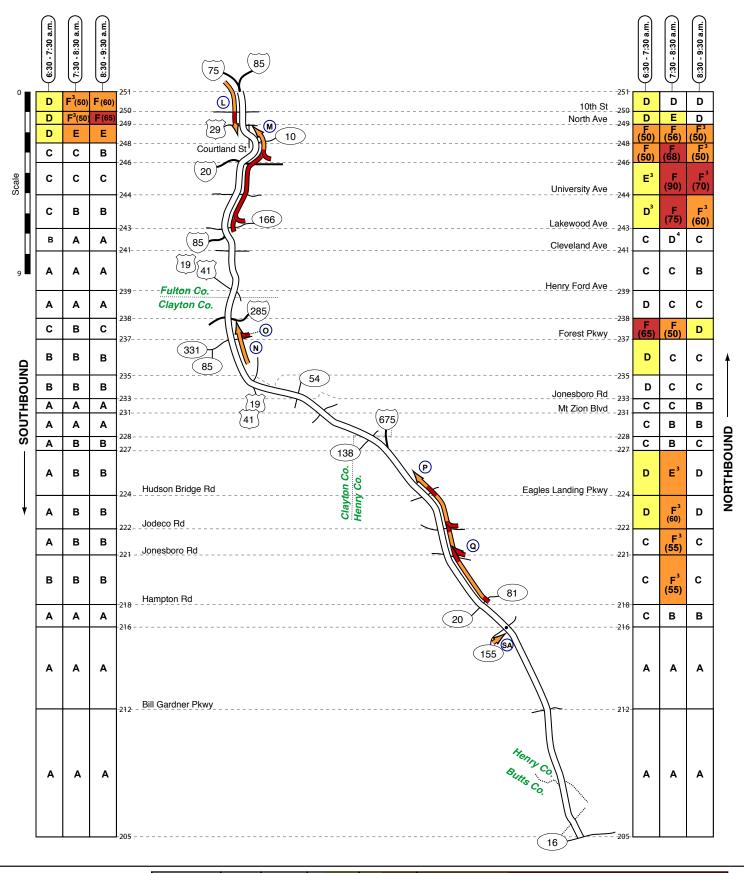
I-75 (Fulton/Clayton & Henry Counties) - Morning

Potential Cause(s): The head of the queue was found at the signal at the head of the Exit 249C ramp; congestion on the two lane ramp extended back into the right lanes (and eventually across all

Potential Cause(s): Factors contributing to the congestion were: 1) traffic entering at the SR 166 and I-20 interchanges and; 2) the two separate lane drops approaching the I-20 interchange (6

Potential Cause(s): The merging associated with the SR 331 and

Potential Cause(s): Traffic entering at the interchanges along this

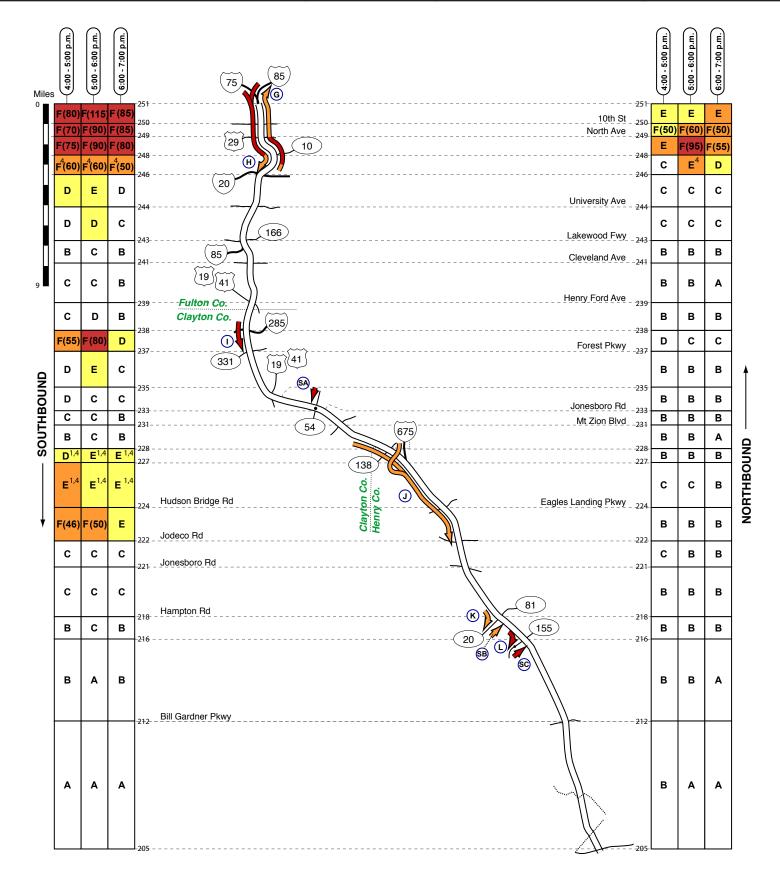
I-75 (Fulton/Clayton & Henry Counties) - Evening

Potential Cause(s): Factors contributing to the congestion were: 1) traffic entering at the interchanges along this corridor; 2) the geometrics of the road (sharp bends) and; 3) the weaving

Potential Cause(s): Factors contributing to the congestion were: 1) the geometrics of the road (sharp bends) and: 2) merging & weaving associated with the interchanges along this corridor.

Potential Cause(s): Factors contributing to the congestion were: 1) the series of lane drops (5 lanes to 4 and 4 lanes to 3) in the vicinity of the I-285 interchange and; 2) traffic entering from

Potential Cause(s): Traffic entering at the I-675 and Hudson

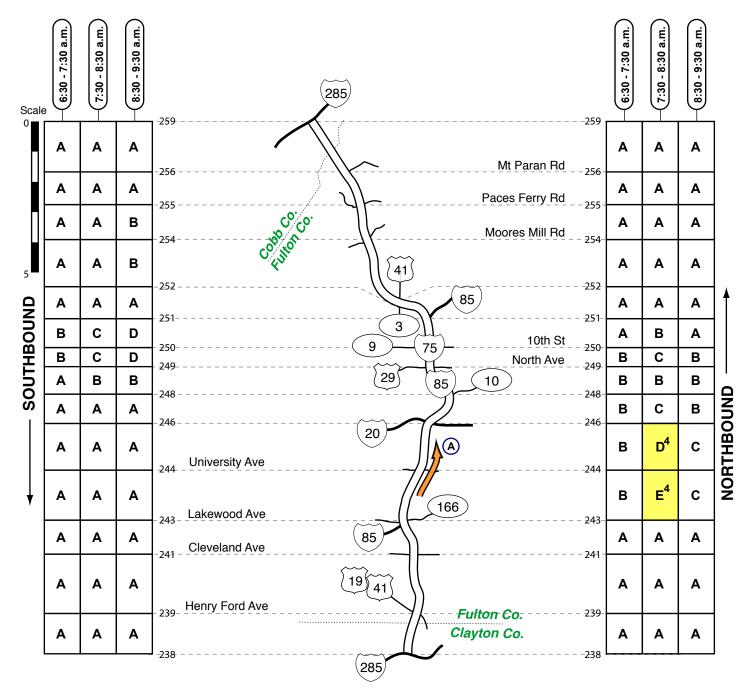
I-75 HOV (Cobb/Fulton & Clayton Counties) - Morning

Congestion Type: HOV Congestion

Frequency: Peak Hour Direction: Northbound

Potential Cause(s): Friction between the congested 'general-purpose' lanes and the HOV facility

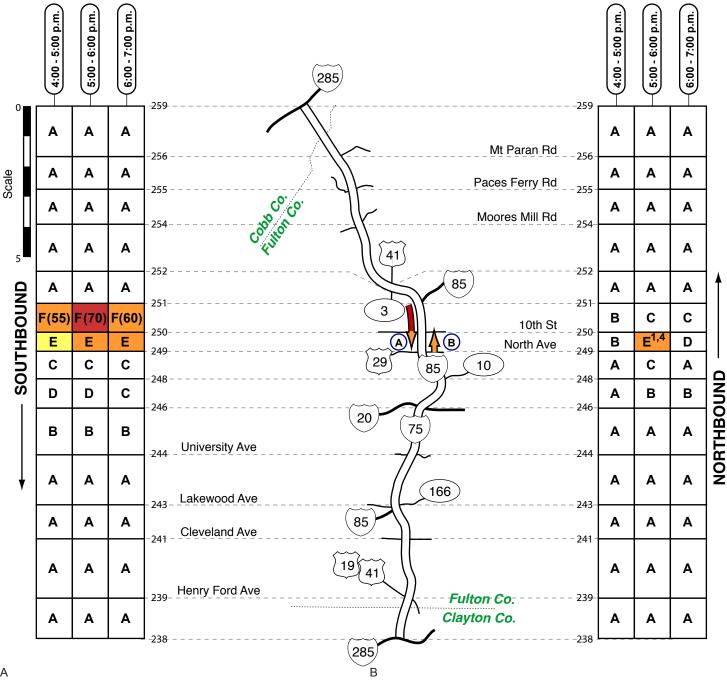
I-75 HOV (Cobb/Fulton & Clayton Counties) - Evening

Congestion Type: HOV Congestion Frequency: Most Observations

Direction: Southbound

Potential Cause(s): Factors contributing to the congestion were: 1) the lane drop (2 lanes to 1) where the I 75 and I-85 HOV facilities merge and; 2) friction between the congested 'generalpurpose' lanes and the HOV facility.

Potential Cause(s): Friction between the 'general-purpose' lanes

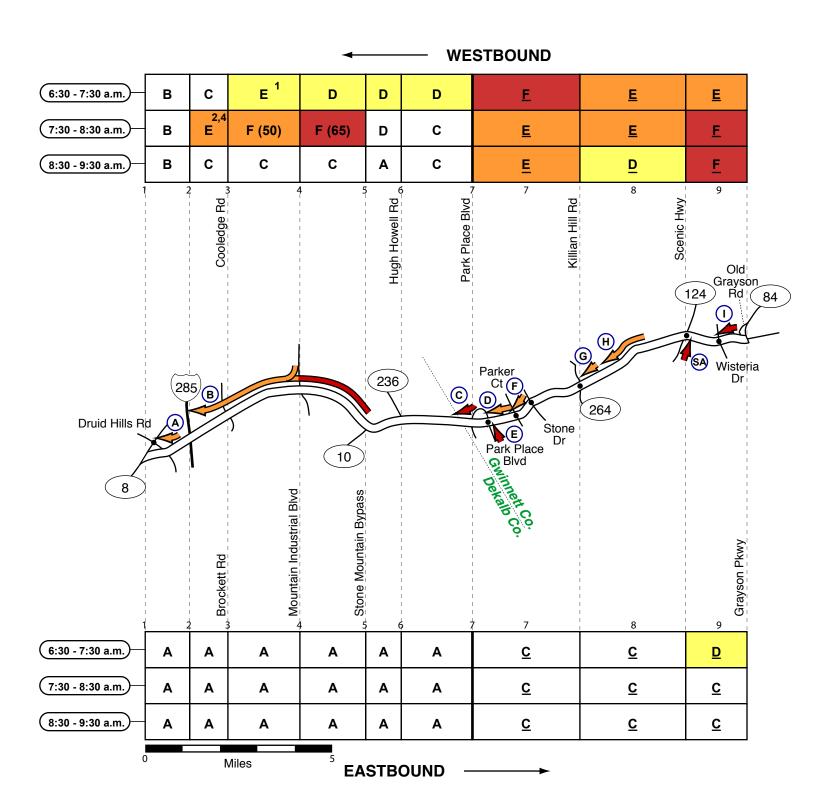
US 78 (Dekalb & Gwinnett Counties) - Morning

Potential Cause(s): Factors contributing to the congestion included: 1) congestion on the ramp to northbound I-285 backed into the right two lanes on US 78 and ultimately across all three lanes; 2) traffic entering the mainline at Stone Mountain Industrial Blvd and; 3) the weaving associated with the SR 10/US 78 split.

Note: The head of the queue was found at the ramp meter.

Note: The head of the gueue was found in the two left-turn lanes at the signal; congestion typically extended back into the mainline

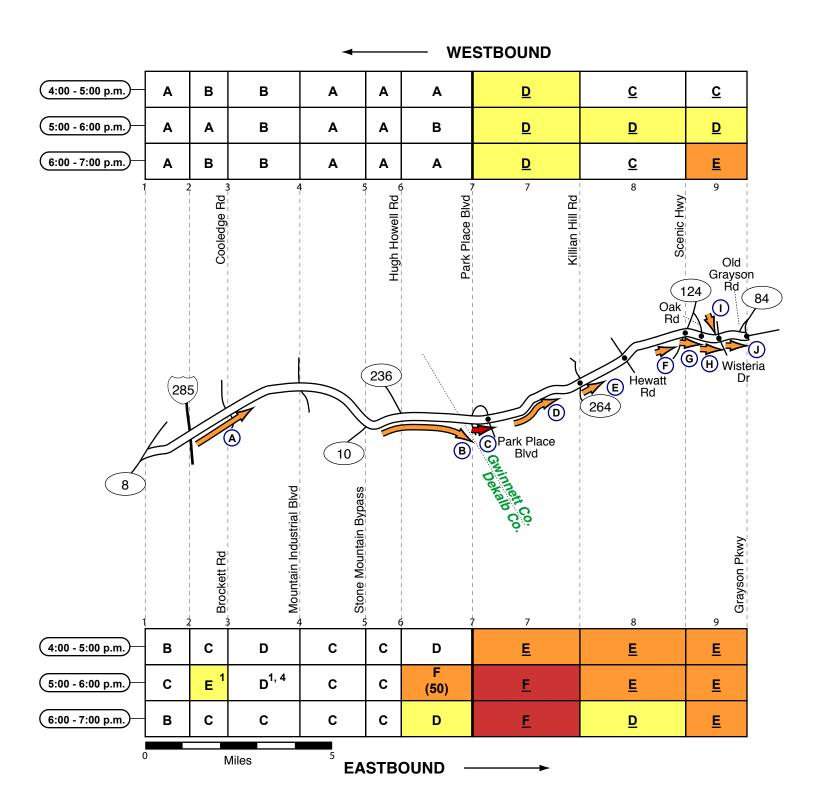
US 78 (Dekalb & Gwinnett Counties) - Evening

Potential Cause(s): Congestion appeared to be caused by traffic entering the mainline from northbound I-285 and the lane drop (4

Potential Cause(s): Congestion appeared to be exacerbated by vehicles exiting at the service road approximately one-half mile before the Park Place Blvd interchange; weaving on the approach

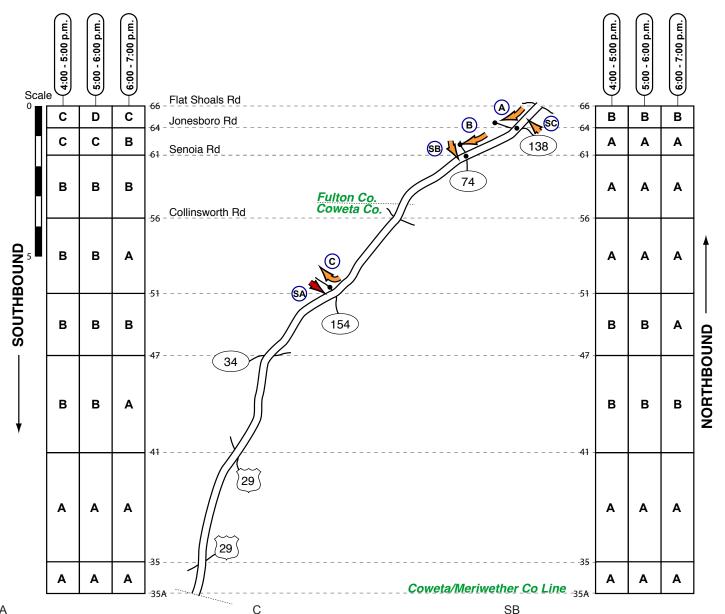
I-85 (Fulton & Coweta Counties) - Evening

Congestion Type: Exit Ramp Queue

Location: SR 138 Frequency: Intermittent Direction: Southbound Queue Population: 20 to 30 vpl

Note: Congestion was found in the two left-

Note: Congestion was found in the left-turn lane at the signal at the head of the ramp.

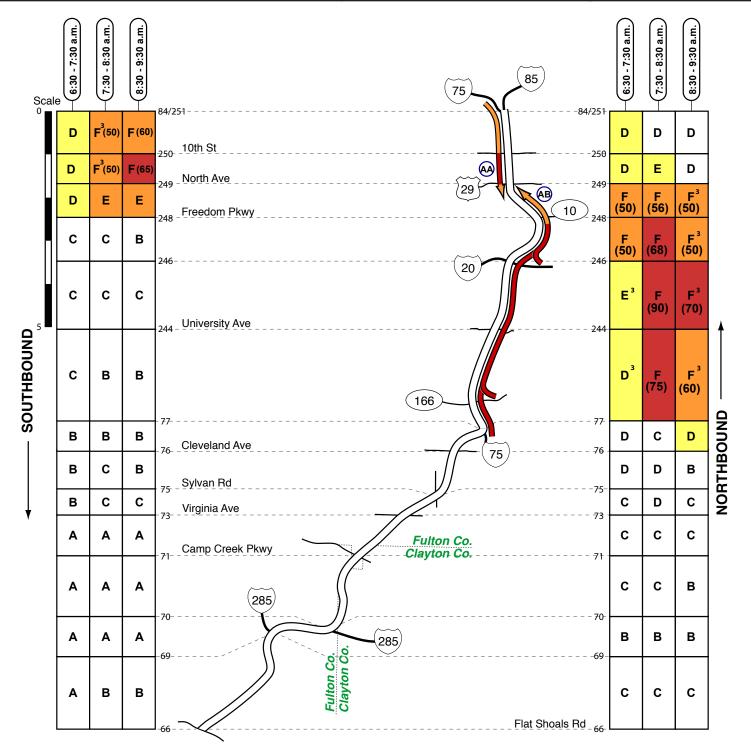
I-85 (Fulton & Clayton Counties) - Morning

Potential Cause(s): The head of the queue was found at the signal at the head of the Exit 249C ramp; congestion on the two lane ramp extended back into the right lanes (and eventually

Potential Cause(s): Factors contributing to the congestion were: 1) traffic entering at the SR 166 and I-20 interchanges and; 2) the two separate lane drops approaching the I-20 interchange (6

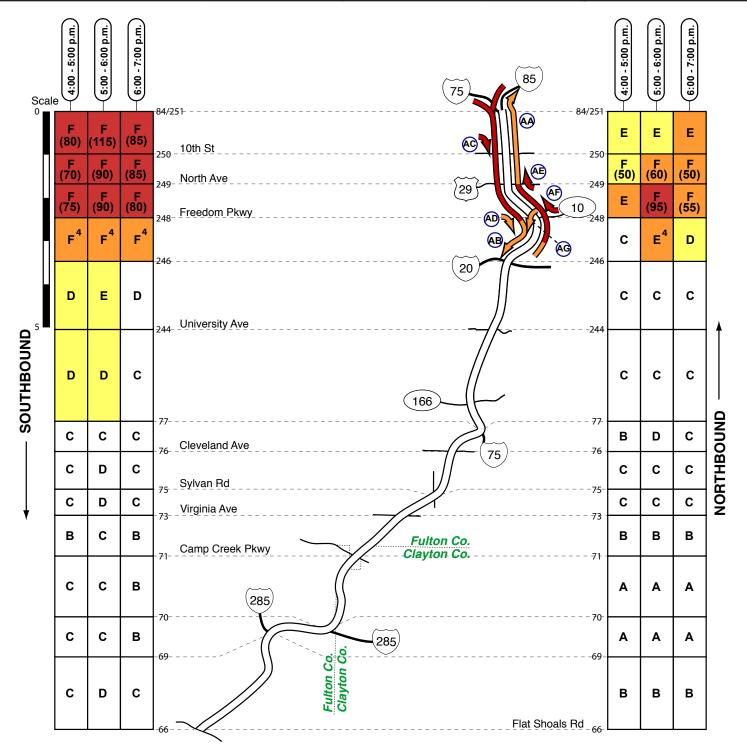
I-85 (Fulton & Clayton Counties) - Evening

Potential Cause(s): Factors contributing to the congestion were: 1) traffic entering at the interchanges along this corridor; 2) the geometrics of the road (sharp bends) and; 3) the weaving

Potential Cause(s): Factors contributing to the congestion were: 1) the geometrics of the road (sharp bends) and: 2) merging & weaving associated with the interchanges along this corridor.
